# Manhole Inspection Summary

Manhole # S04YY1009MH

Insp Date: **7/5/06 11:19 AM**

**Location** Address: **3819 BARTWOOD RD**

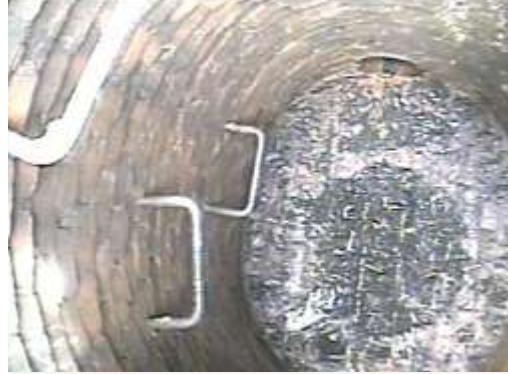
Top View

Adjustment, Corbel, and Barrel infiltration.  
Channel debris.

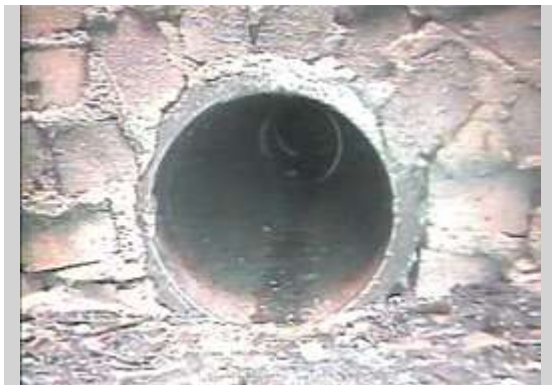
Pipe Out @ 12 O'Clock

Comments **The O12 pipe picture shows Barrel deterioration and infiltration.**

Condition: ☐ Sound ☐ Cracked ☐ Root Intrusion ☐ Loose Brick ☒ **Deteriorated**

Infiltration: ☐ None ☐ Joint ☐ Cracks ☒ **Mortar** ☐ Roots ☒ **Wall**

Infiltration: **Evidence**
